Gibson Road: County Road 98 to College Street

Corridor Collision Profile

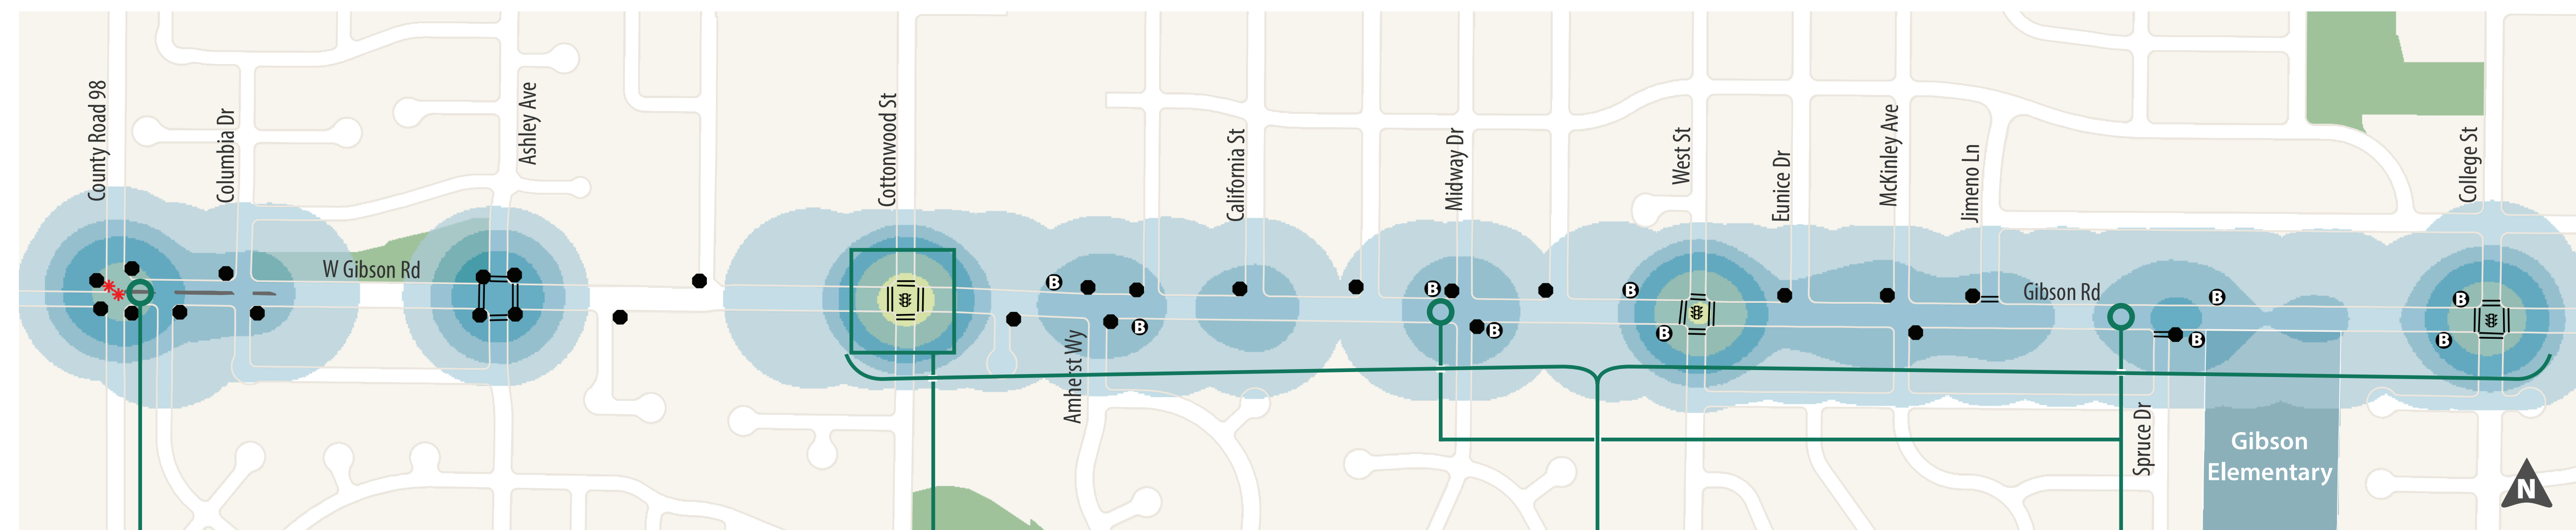
In the Map:

- ⚡ Traffic Signal
 - Stop Sign
 - Crosswalk
 - Median
 - ★ Flashing Beacon
 - Ⓛ Bus Stop
- Low (1) **COLLISION INTENSITY** High (20)

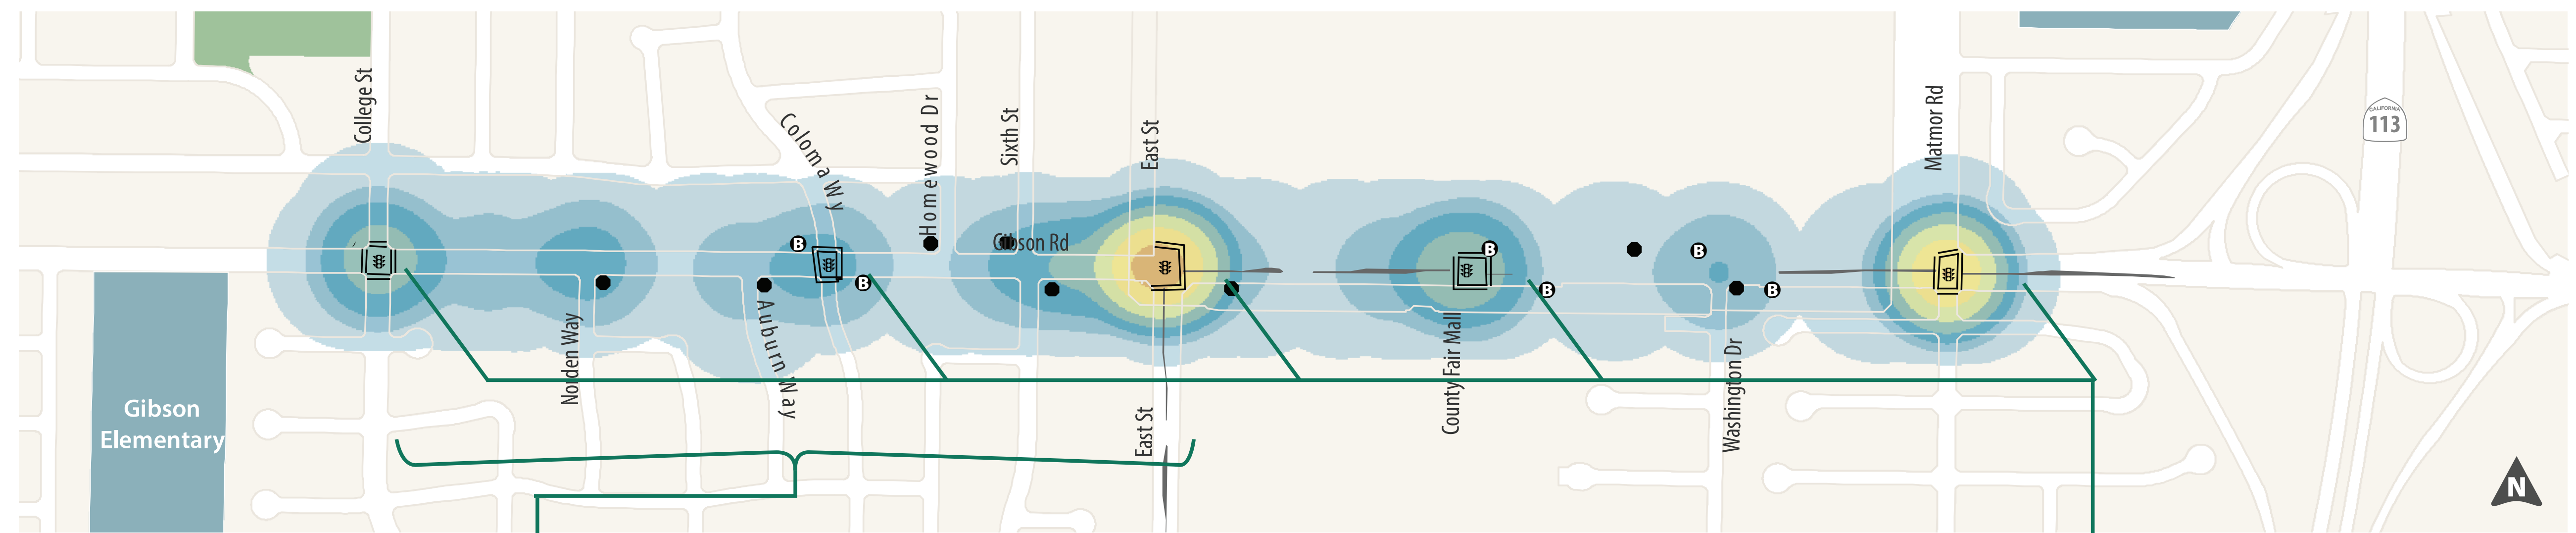
In the Map:

- ⚡ Traffic Signal
 - Stop Sign
 - Crosswalk
 - Median
 - ★ Flashing Beacon
 - Ⓟ Bus Stop
- Low (1) **COLLISION INTENSITY** High (20)

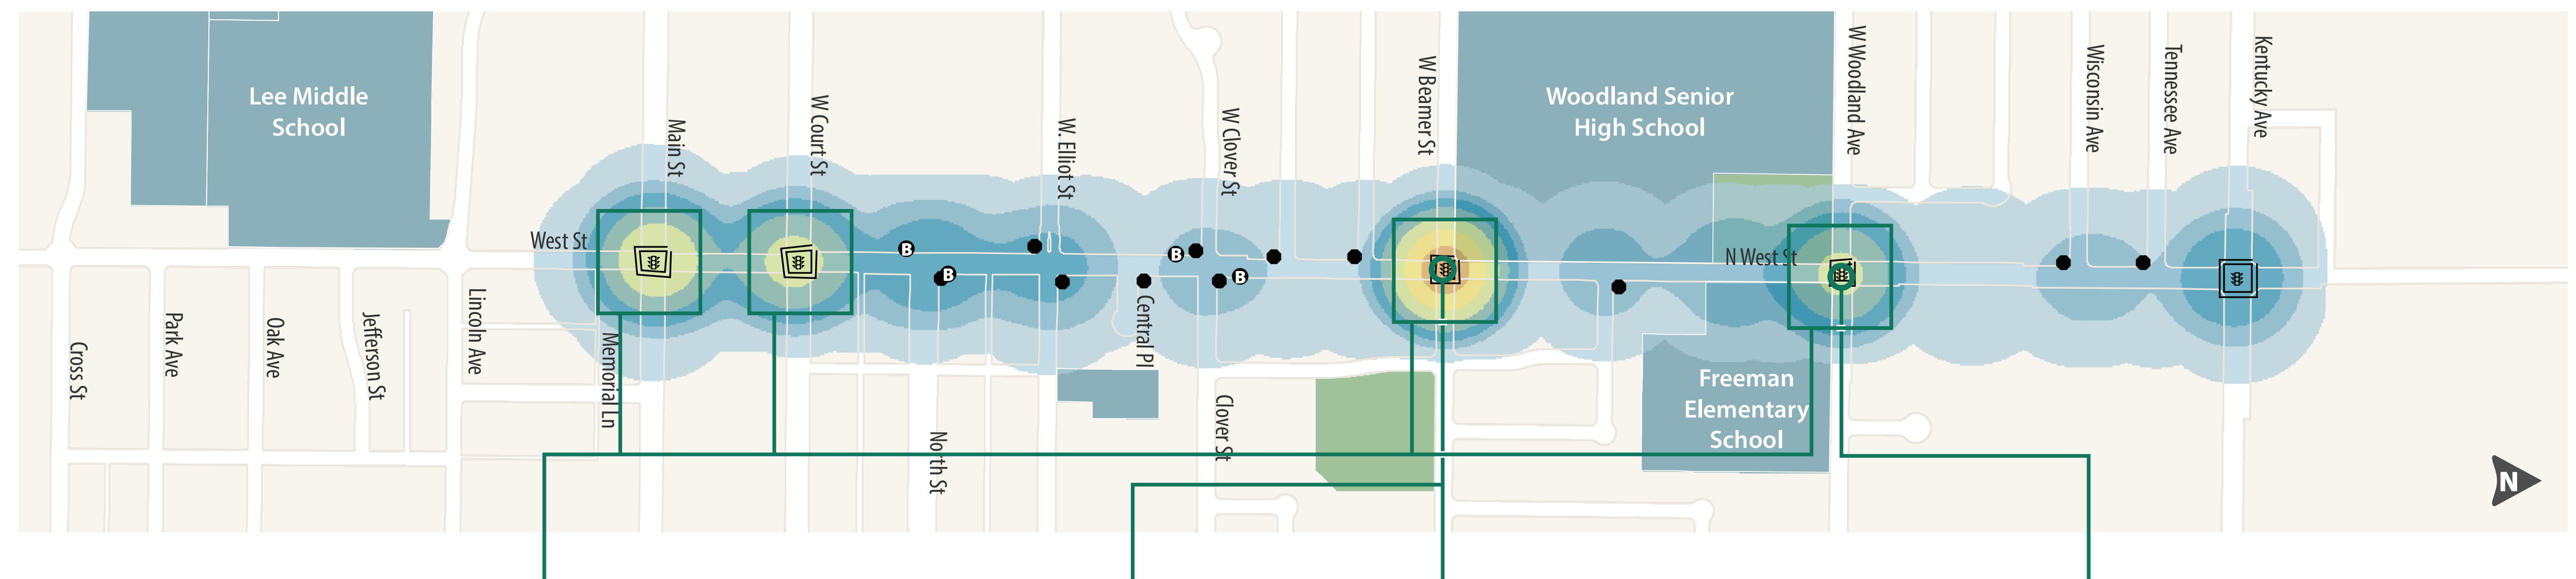
In the Map:

- ⚡ Traffic Signal
 - Stop Sign
 - Crosswalk
 - Median
 - ★ Flashing Beacon
 - Ⓟ Bus Stop
- Low (1) **COLLISION INTENSITY** High (20)

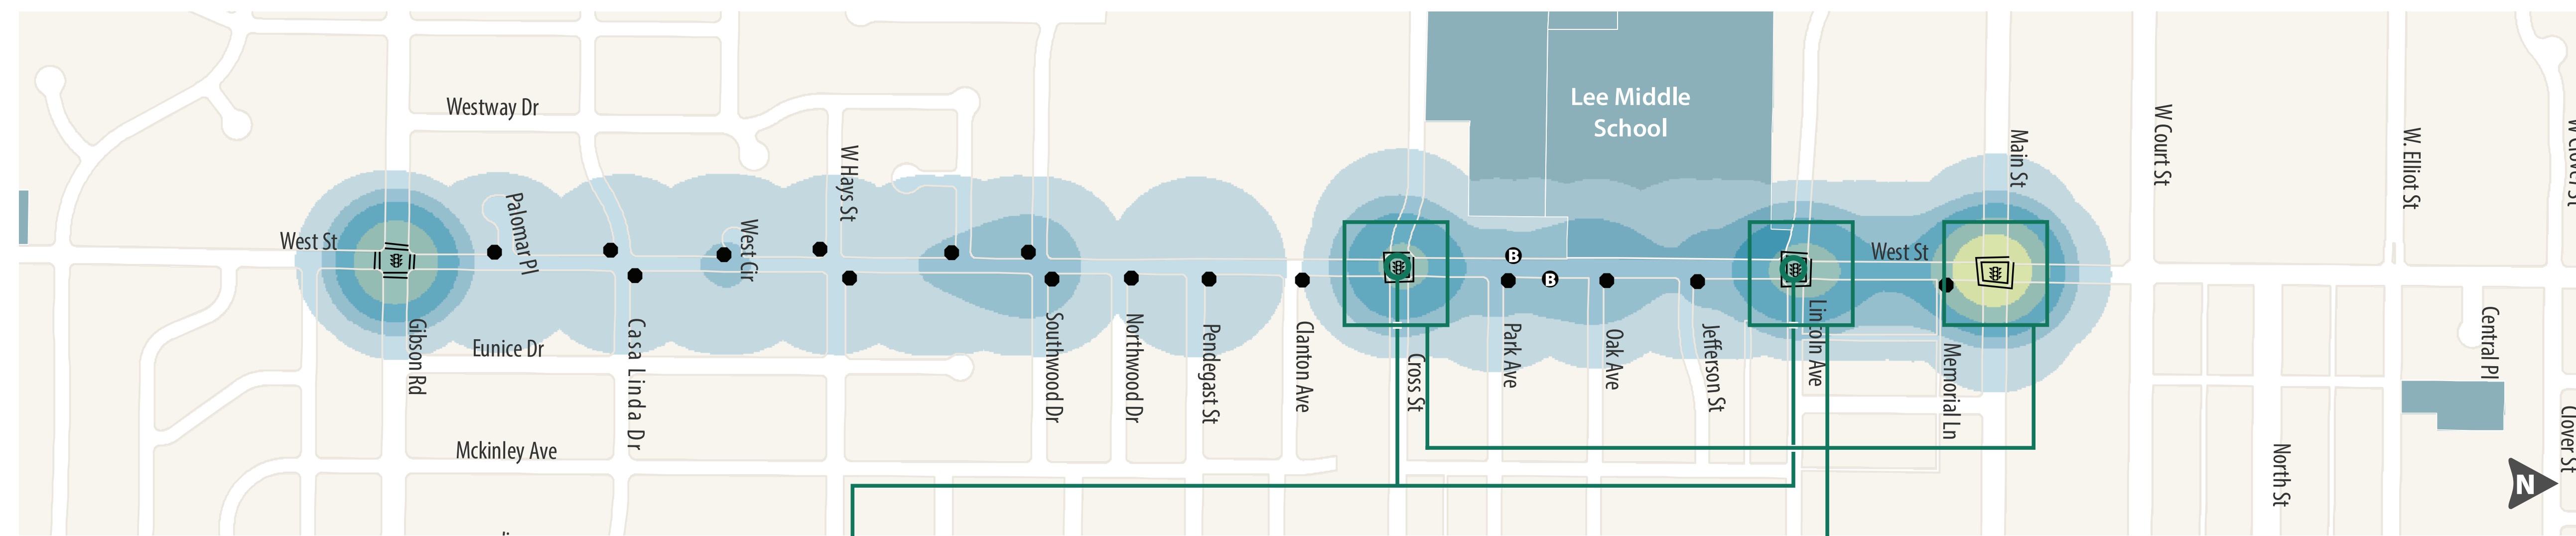
In the Map:

- ⚡ Traffic Signal
 - Stop Sign
 - Crosswalk
 - Median
 - * Flashing Beacon
 - ⊕ Bus Stop
- Low (1) **COLLISION INTENSITY** High (20)
