Gibson Road: County Road 98 to College Street

Corridor Collision Profile

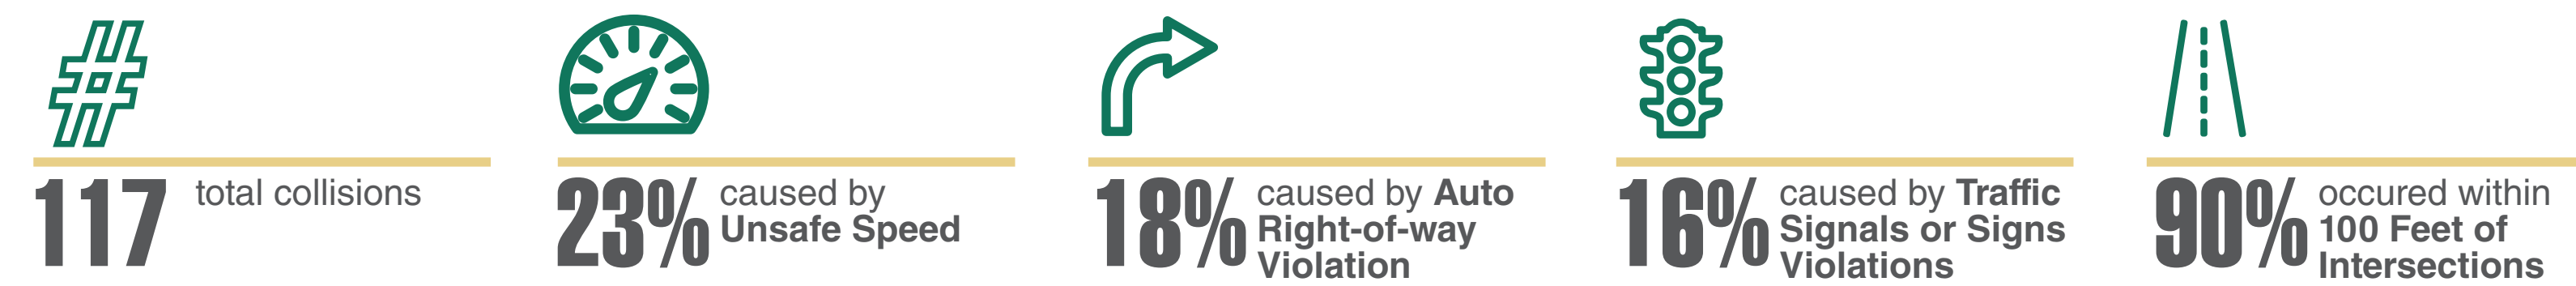
What do we know about these collisions (2009-2016)?

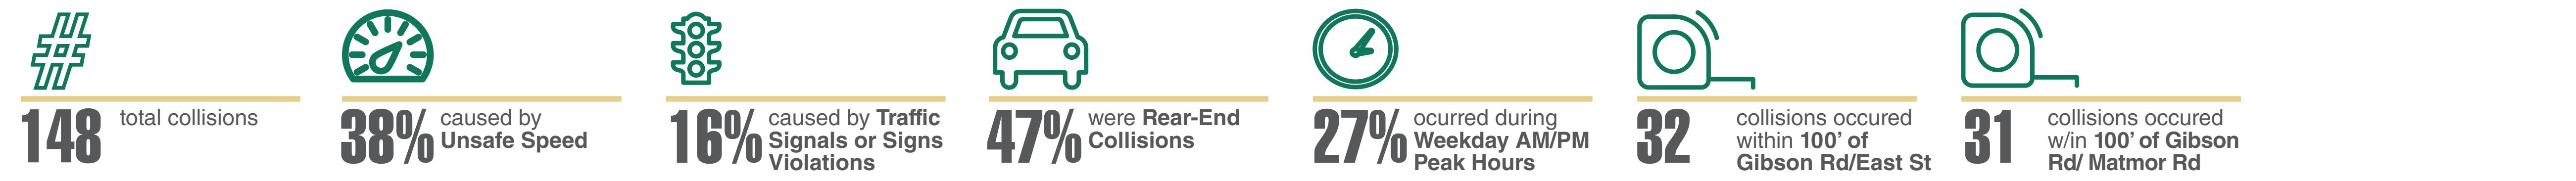
What do we know about these collisions (2009-2016)?

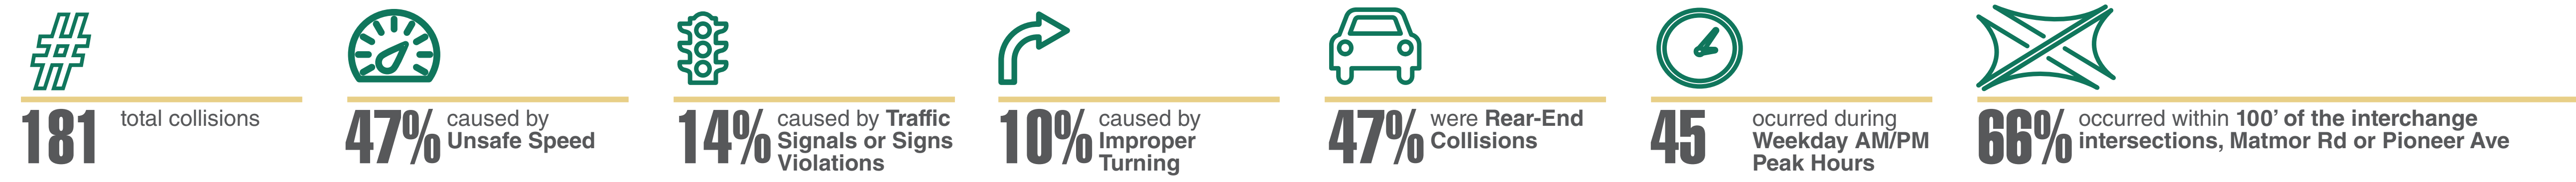
What do we know about these collisions (2009-2016)?

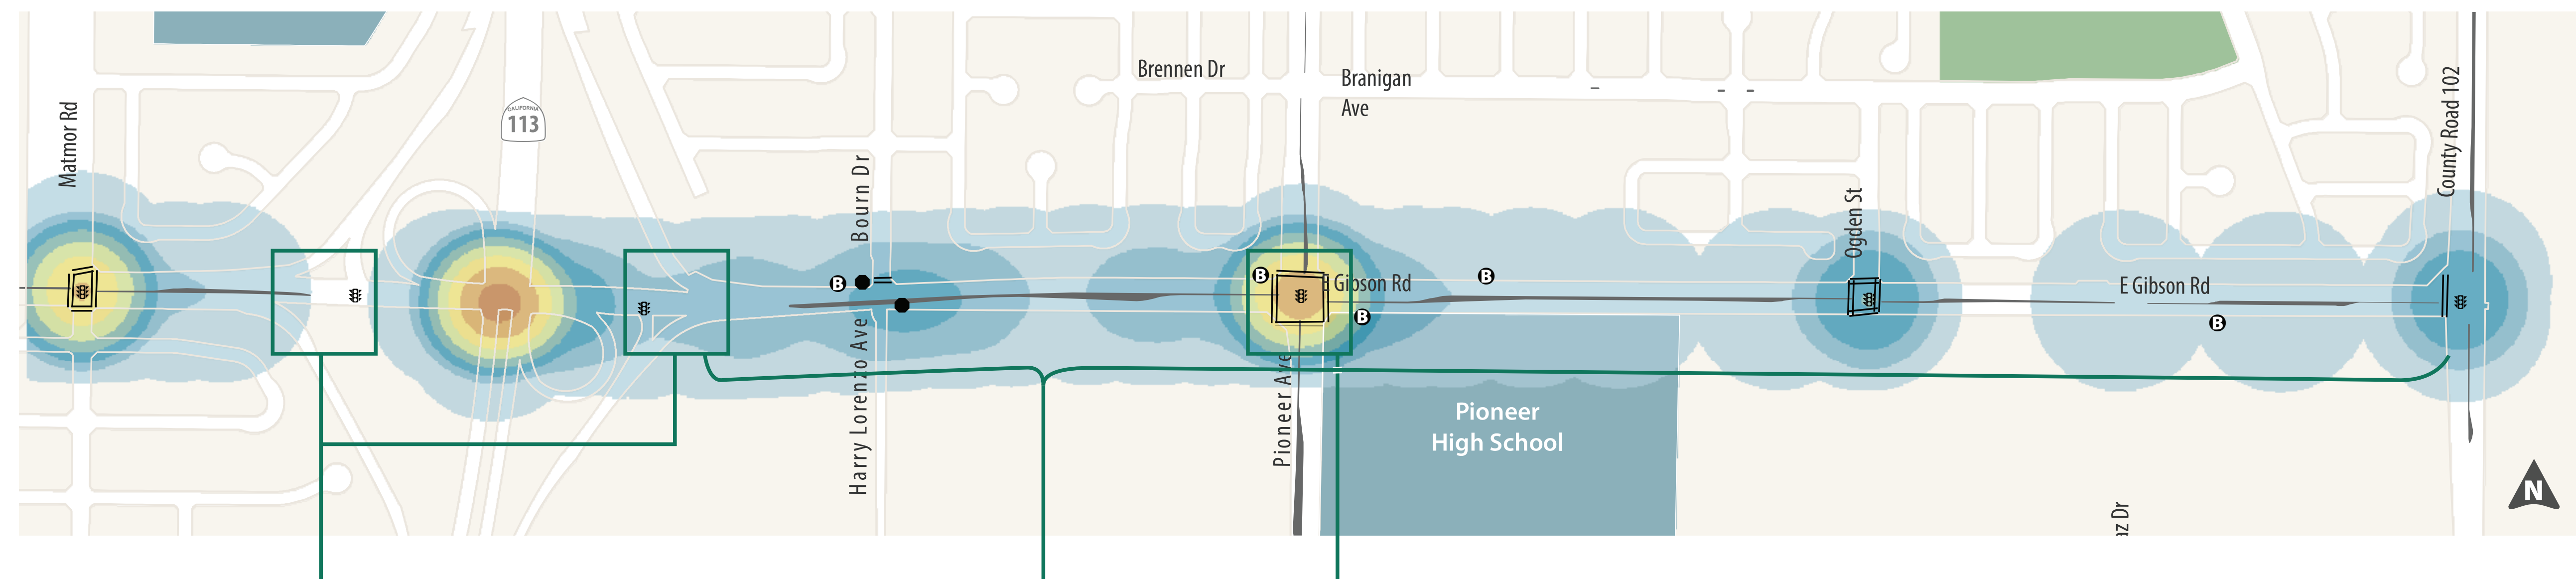
In the Map:

- ⊠ Traffic Signal
 - Stop Sign
 - Crosswalk
 - Median
 - * Flashing Beacon
 - ⊙ Bus Stop
- Low (1) **COLLISION INTENSITY** High (20)

33 separate incidents and in zero fatalities. Almost half of the collisions in this corridor were due to unsafe speed. The rest of the major collision causes included traffic signals or signs violations, improper turning, and automobile right-of-way violations. Due to the

presence of the high school, 23% of collisions involved a driver, bicyclist, or pedestrian age 18 years or under. 26 of these youth-involved collisions occurred between 7:00 AM and 4:00 PM on weekdays, with most being triggered by unsafe speeds.

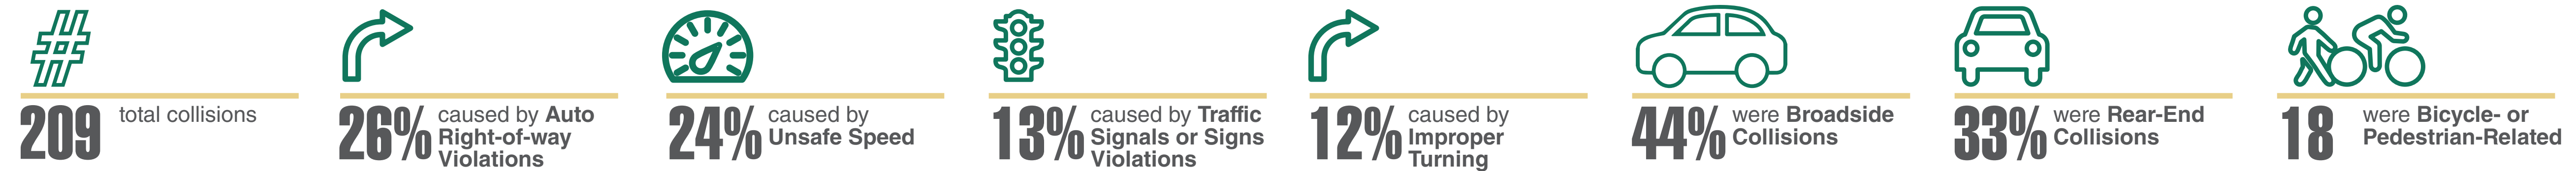
What do we know about these collisions (2009-2016)?

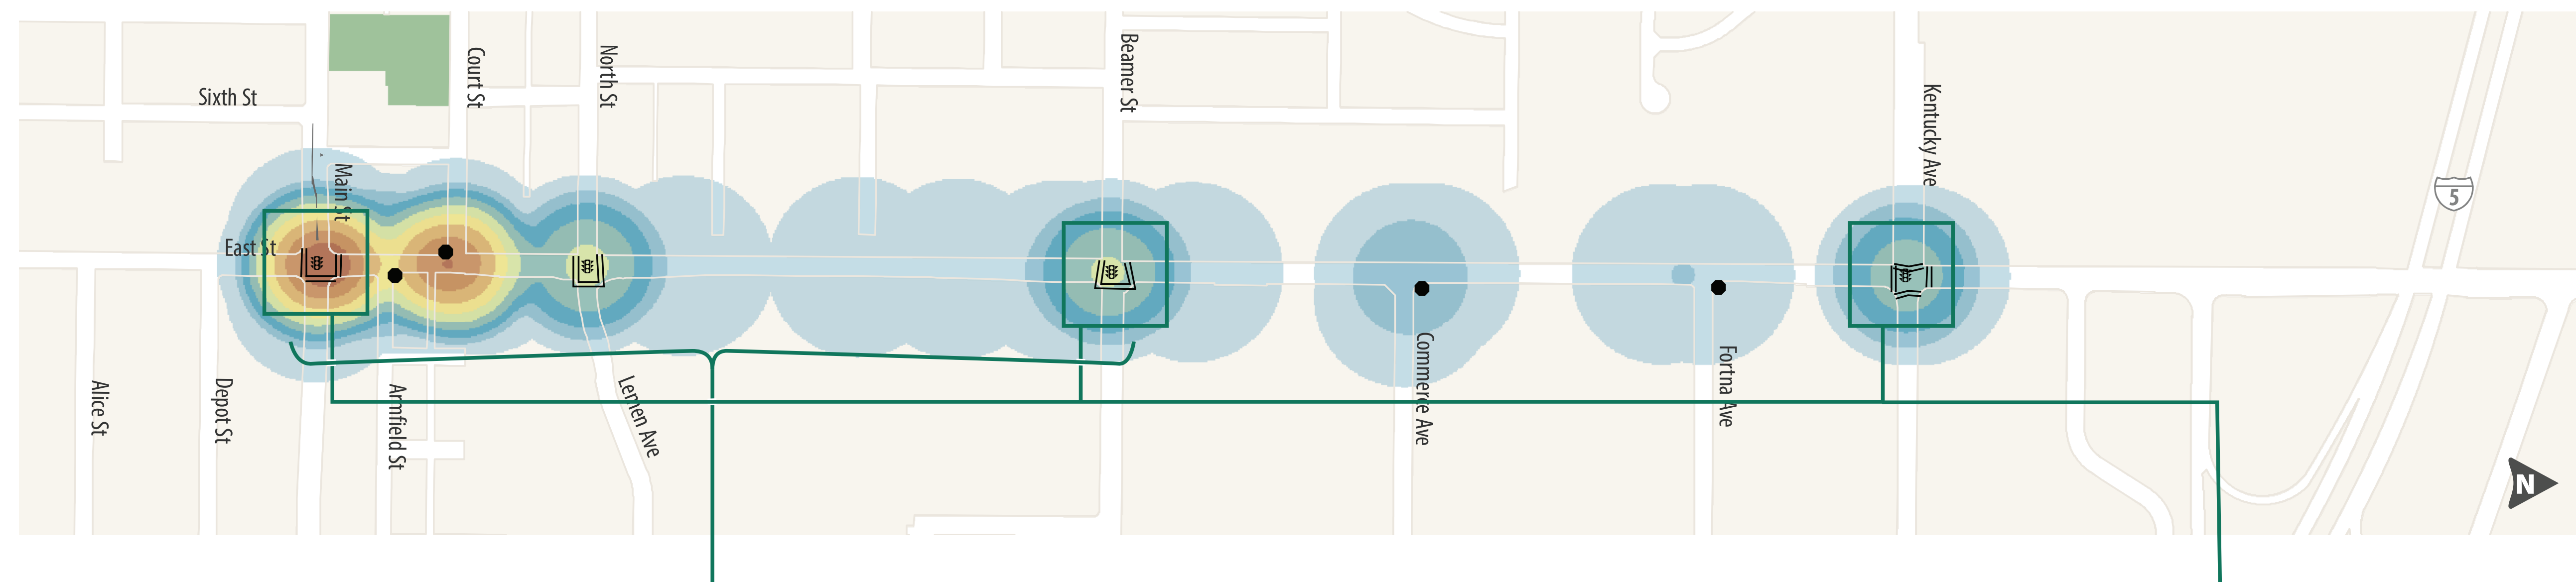
In the Map:

- Traffic Signal
- Stop Sign
- = Crosswalk
- Median
- * Flashing Beacon
- ⊙ Bus Stop

the west. From 2009 to 2016, there were 209 crashes along or near this corridor, including 6 severe injury collisions and 1 fatality. About 1/4 of all collisions were caused by auto right-of-way violations, 1/4 by unsafe speed, and

1/4 by traffic signal/sign violations or improper turning. In total, there were 12 bicycle-related collisions, with 11 between Main St and Lemen Ave. Five of the 6 pedestrian-related collisions occurred at the East St/Main St intersection.

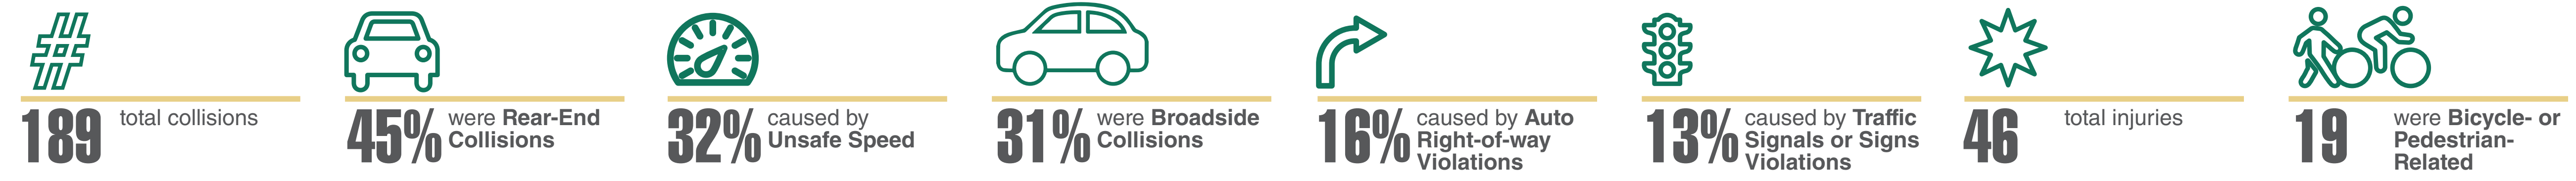
What do we know about these collisions (2009-2016)?

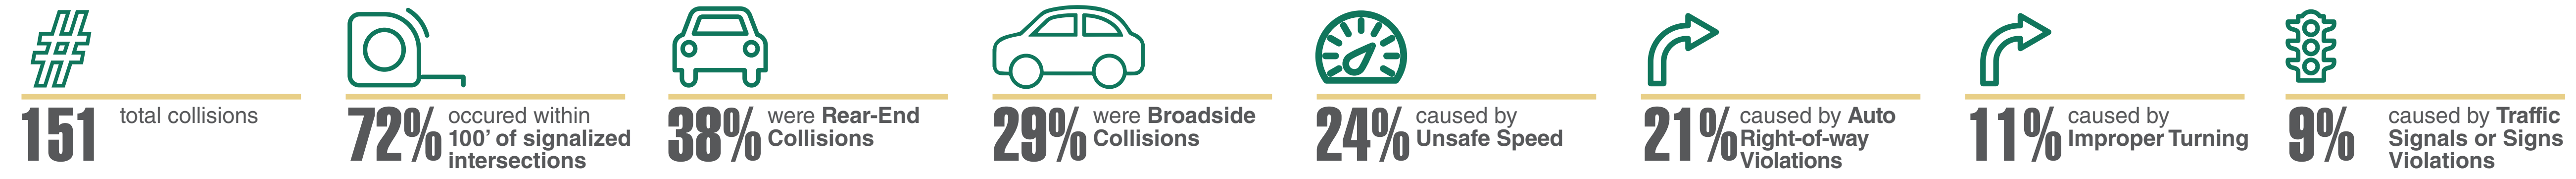
What do we know about these collisions (2009-2016)?

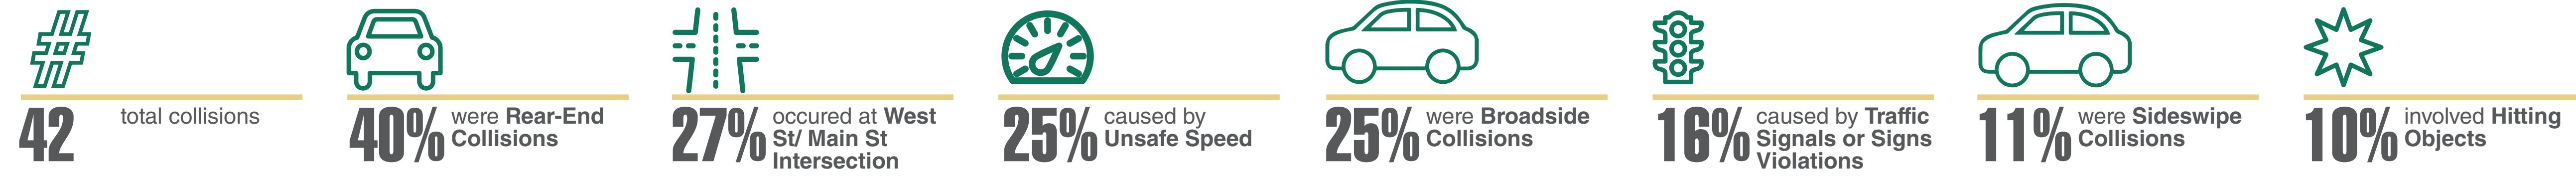
What do we know about these collisions (2009-2016)?

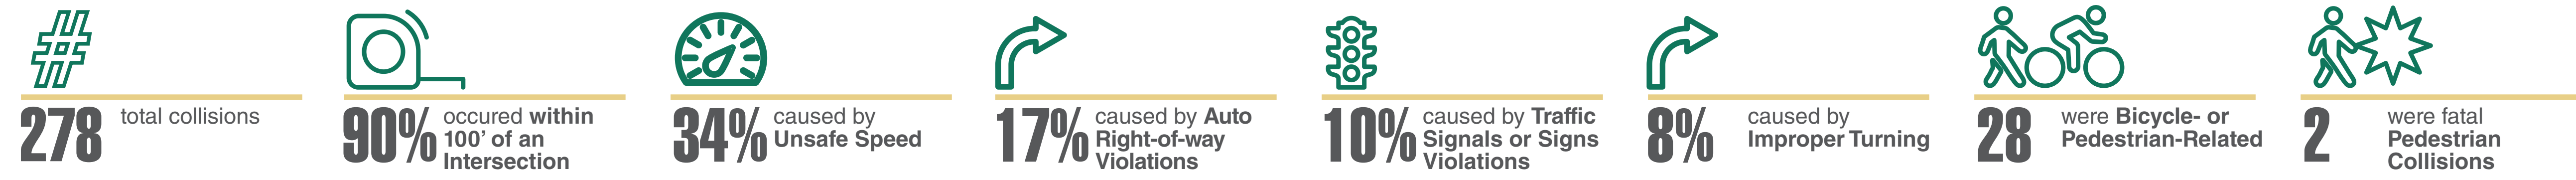
What do we know about these collisions (2009-2016)?

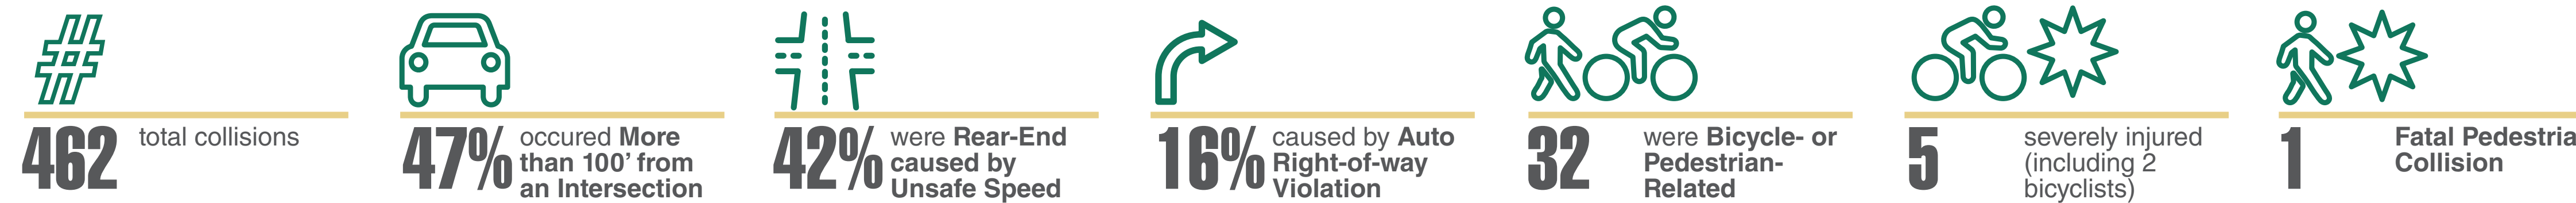
What do we know about these collisions (2009-2016)?

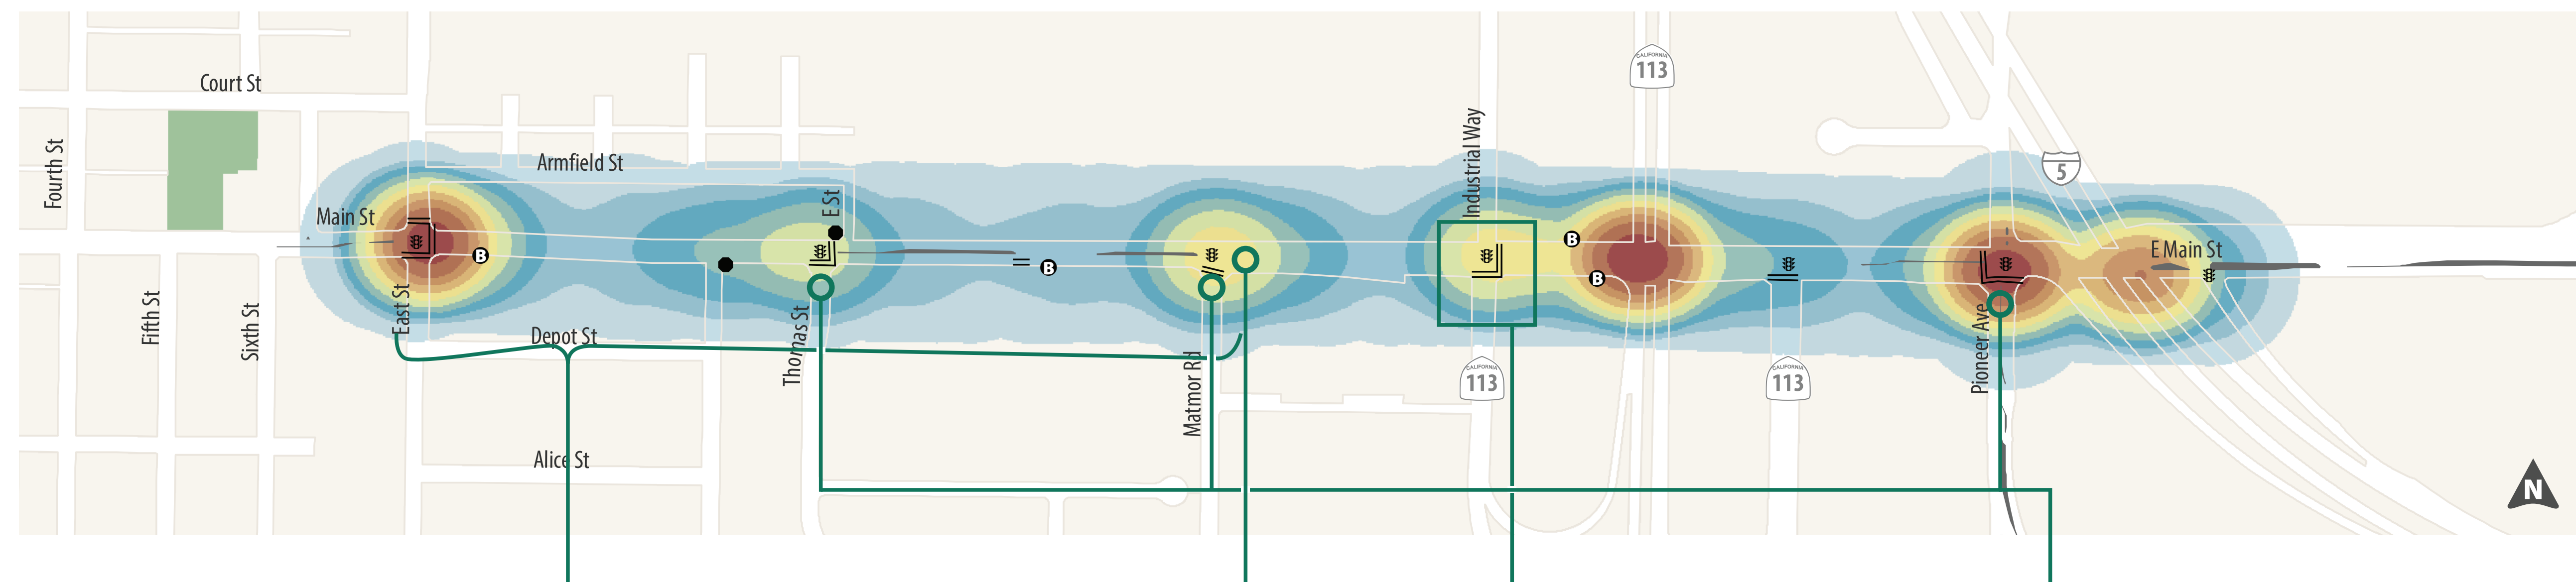
In the Map:

- Traffic Signal
 - Stop Sign
 - Crosswalk
 - Median
 - * Flashing Beacon
 - ⊕ Bus Stop
- Low (1) COLLISION INTENSITY High (20)

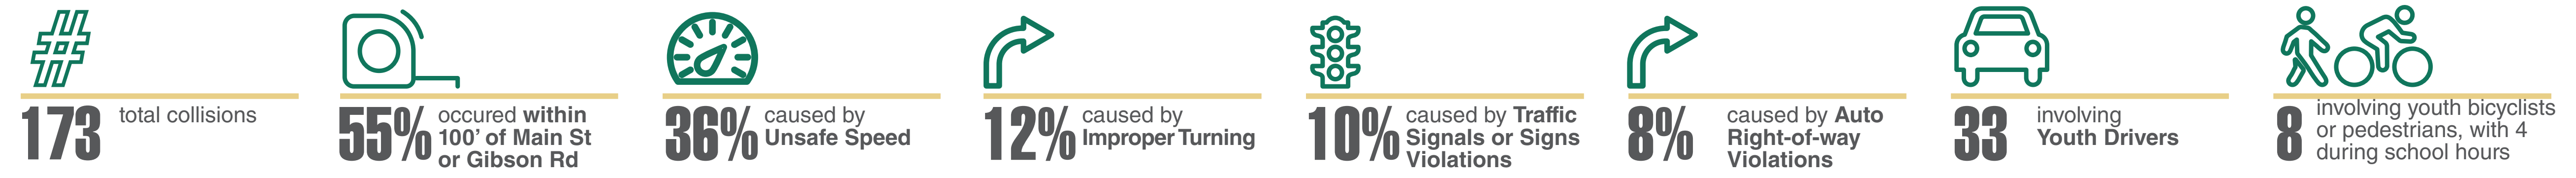
What do we know about these collisions (2009-2016)?
